# BUILDING INSPECTION SERVICES

## PRACTICAL COMPLETION INSPECTION - (PCI)

1 north st north pole  
Crib Point, VIC 3919

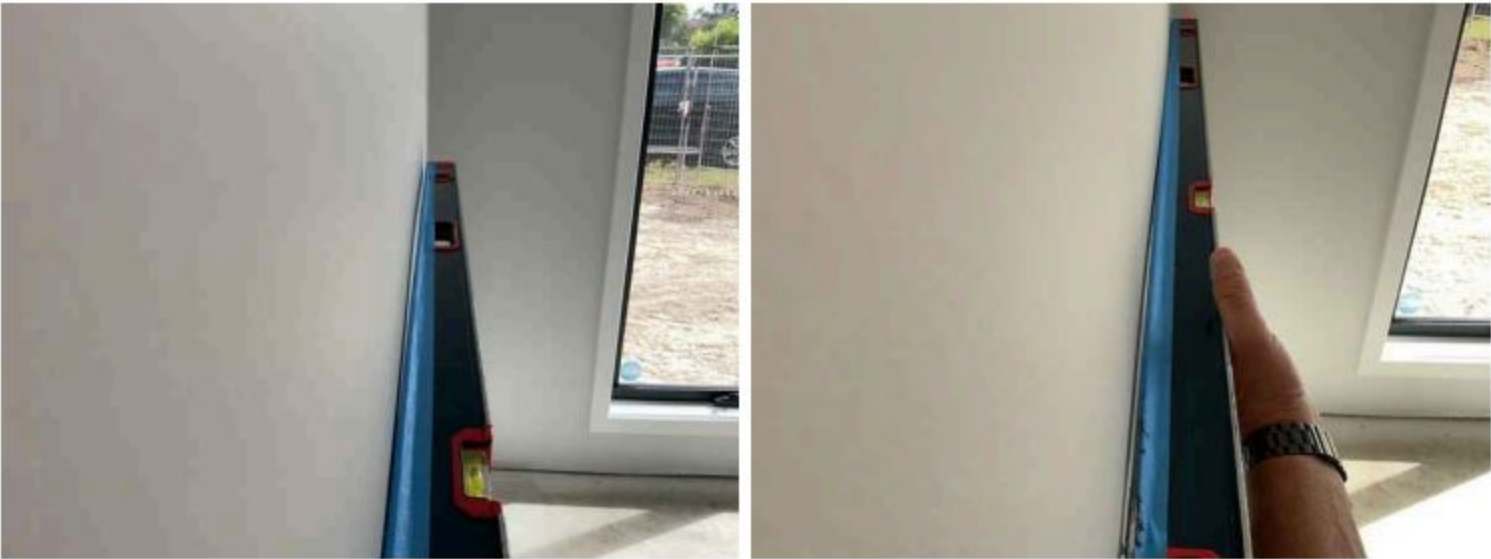
2.1.1 Entery

#### WALLS NOT STRAIGHT

THE WALLS HAVE A TOLERANCE OF 5 MM IN 1.8 MTS  
WHEN MEASURED THE WALLS EXCEEDED THIS

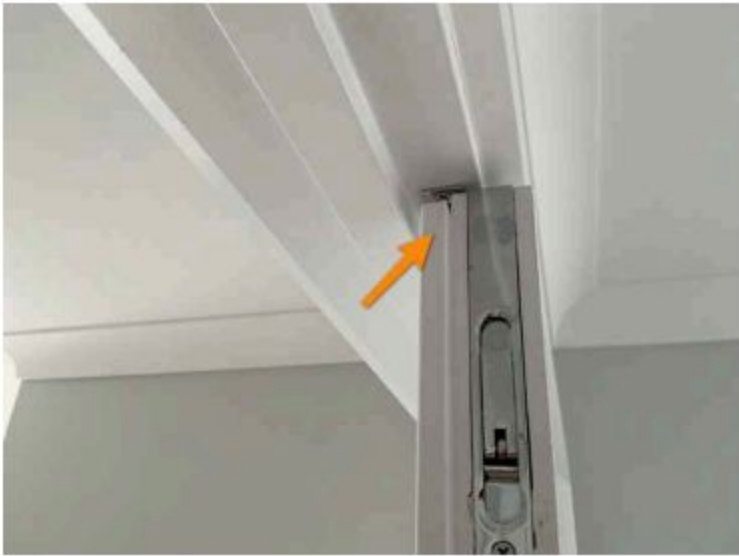
3.2.1 Bedroom 2

DOOR LATCH TO TOP OF DOOR DOES NOT ENGAGE

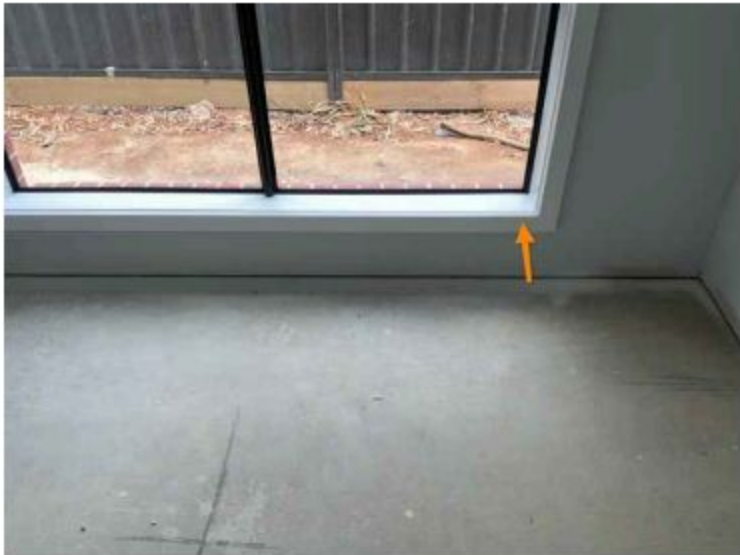
3.3.1 Bedroom 3

**WINDOW ARCHITRAVE MARGINS NOT EVEN**

THE MARGINS AROUND THE WINDOW FRAME ARE NOT EVEN

Recommendation

Contact a qualified professional.

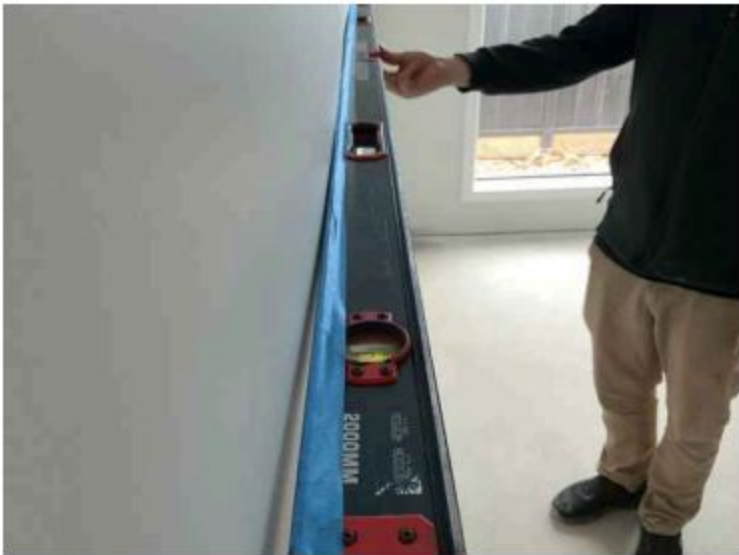
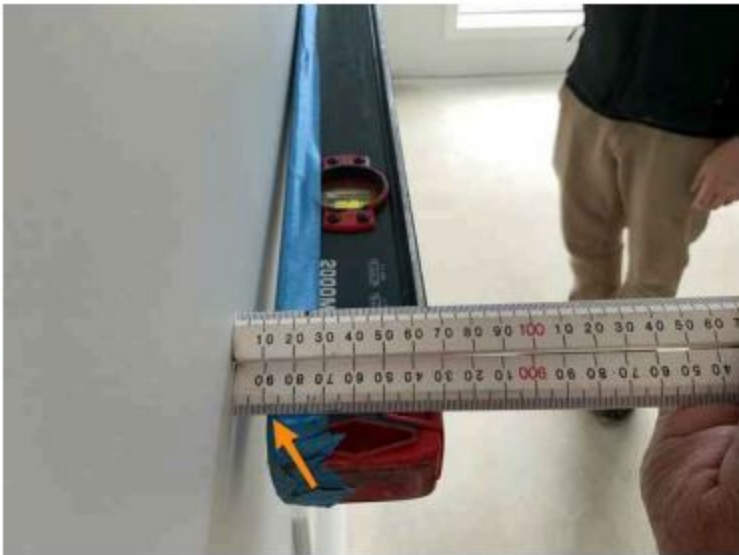
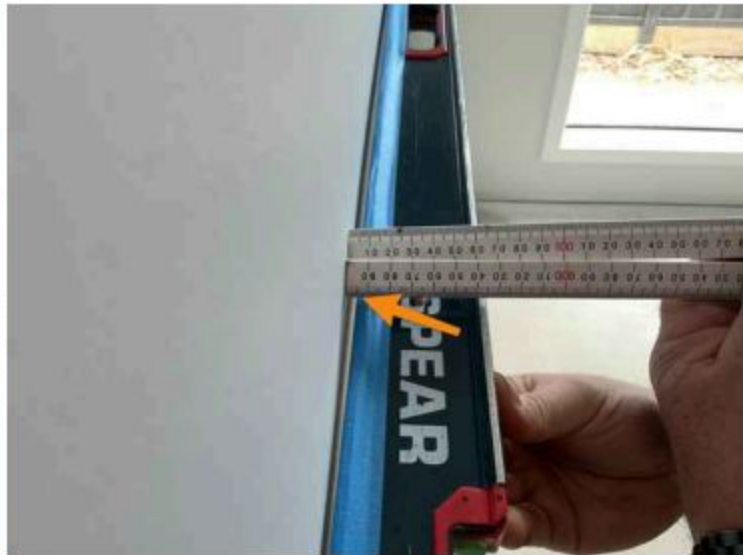
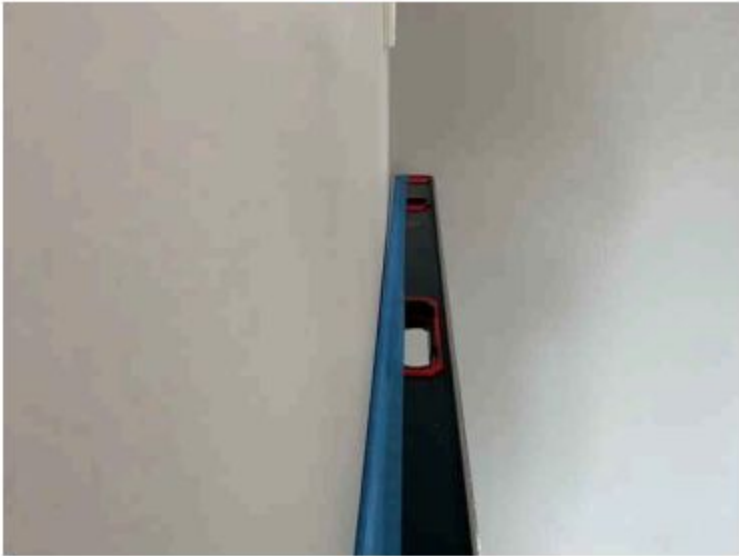
3.3.2 Bedroom 3

**WALLS OUT OF TOLERANCE**

AUSTRALIAN STANDARDS ALLOW FOR A 5 MM TOLERANCE IN 1.8 MTS  
WHEN MEASURED THE WALL EXCEED THIS

Recommendation

Contact a qualified professional.

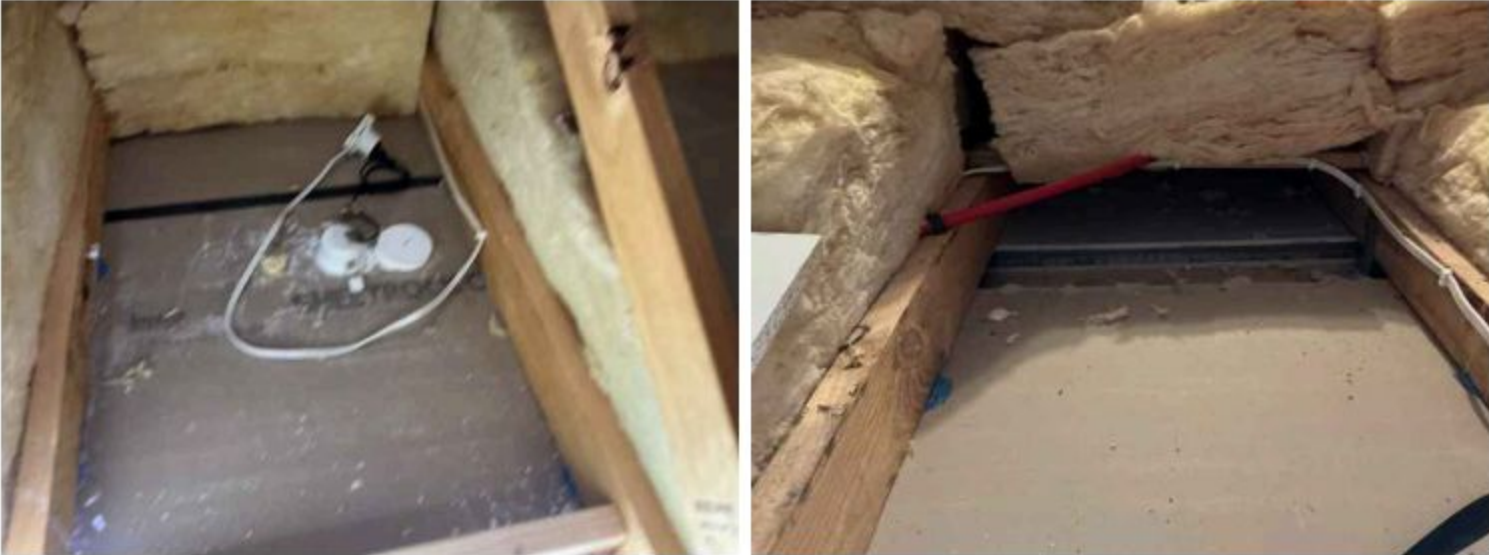
13.1.1 General

**GAPS IN INSULATION OBSERVED**

Requires rectifying.

Recommendation

Contact a qualified professional.

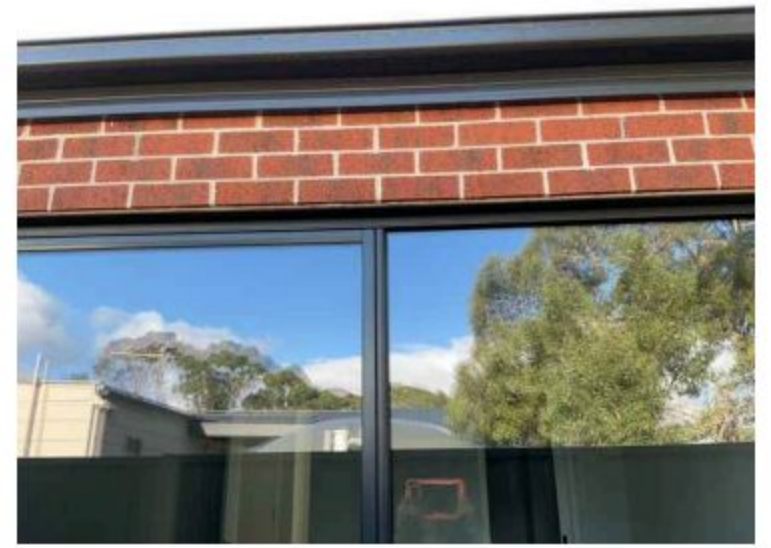
16.2.1 Wall Structure

**MISSING WEEP HOLES ABOVE WINDOW**

AS PER NCC CODE 5.7.5 WEEP HOLES ARE DEFECTIVE IF THEY ARE NOT AT 1.2 m CENTRES

When measured, this window exceeded the allowable amount.

Recommendation

Contact a qualified professional.
